**PRELIMINARY REPORT ON  
SERIOUS INCIDENT TO M/S FLAPS AVIATION PVT. LTD.  
BEECHCRAFT KING AIR C-90A AIRCRAFT, VT-SLK  
AT HISAR AIRPORT ON 14.07.2026**

**GOVERNMENT OF INDIA  
MINISTRY OF CIVIL AVIATION  
AIRCRAFT ACCIDENT INVESTIGATION BUREAU**

## Preliminary Report: Serious Incident involving M/s Flaps Aviation Pvt. Ltd. C-90A aircraft VT-SLK at Hisar airport, Haryana, India on 14<sup>th</sup> July 2026.

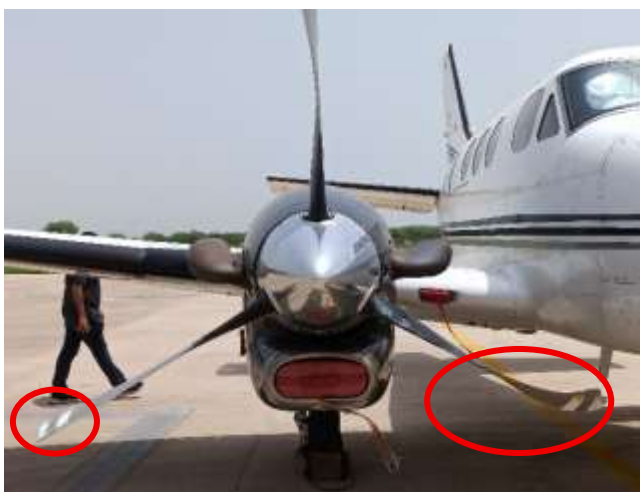
**FIG 2: Damage to RH Propeller**

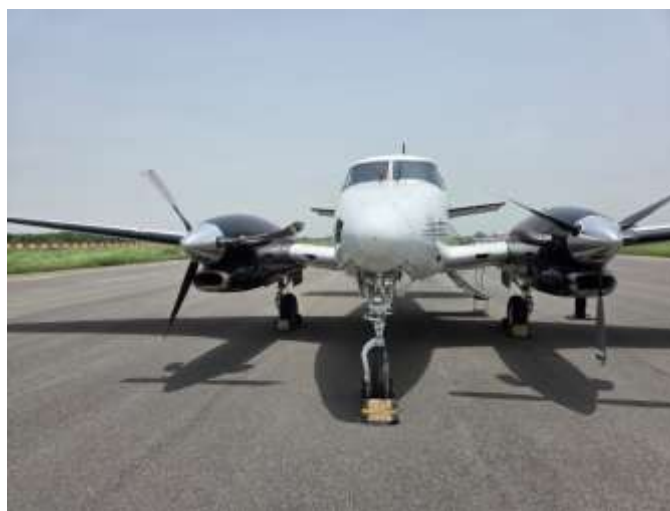
**Final Position of the aircraft**

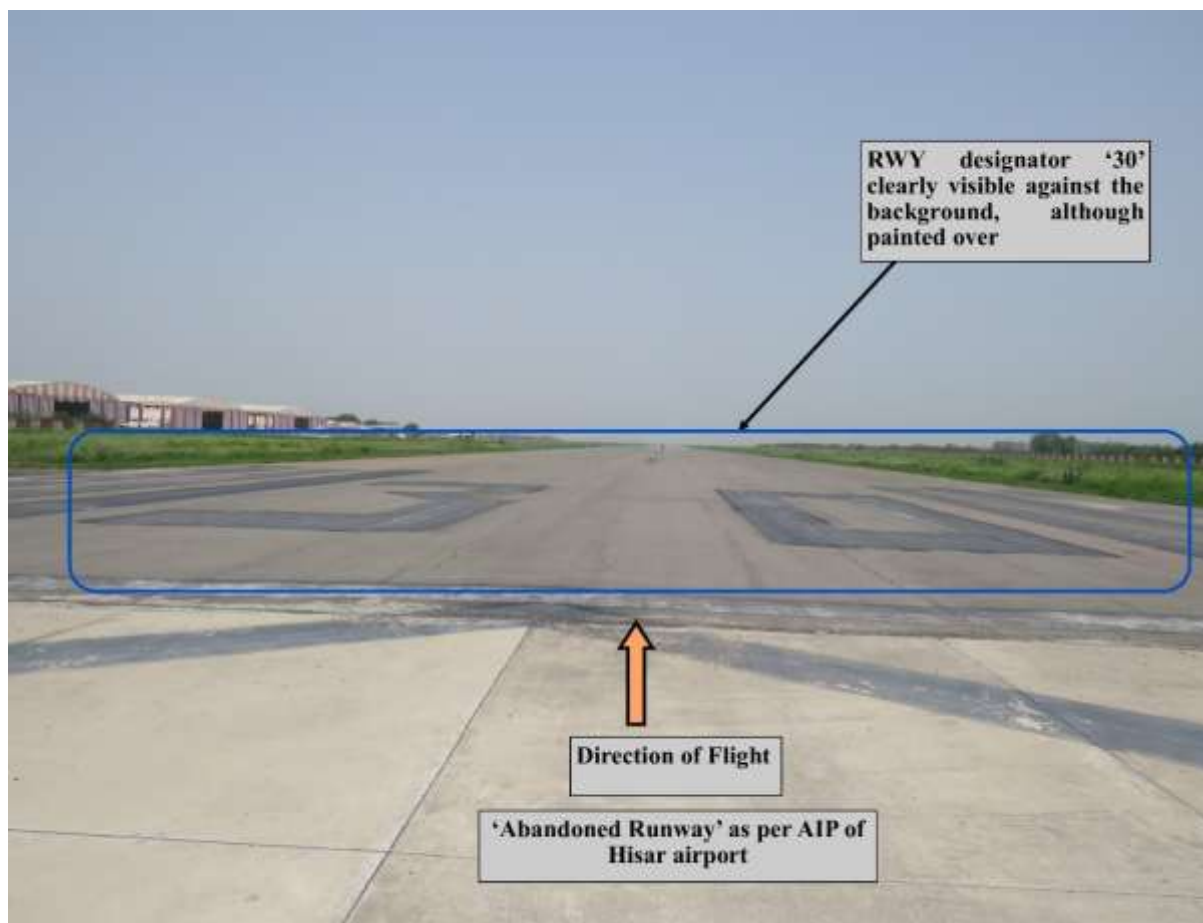
- 'Abandoned Runway' markings still stand out in contrast against the pavement, though the markings have been painted black.
- RWY designator marking for RWY30 has been painted over with black paint which is still readable as 30, along with the threshold markings and Chevron marking ahead of the runway and the runway centre line marking [FIG 8].

**FIG 8: 'Abandoned Runway' portion ahead of RWY30**

- a) AAI-Hisar (Aerodrome License holder) to obliterate/ remove the RWY markings on the abandoned runway at Hisar airport, in a manner that it prevents visibility of markings on the abandoned runway.
- b) AAI-Hisar (Aerodrome License holder) to ensure that, closed runway markings are placed at each end extremity of the runway as per DGCA regulations.
- c) AAI may consider to include a 'caution' in the relevant charts of Hisar airport regarding the existence of pavement- 'abandoned runway' in the approach path (in-line) with RWY30.

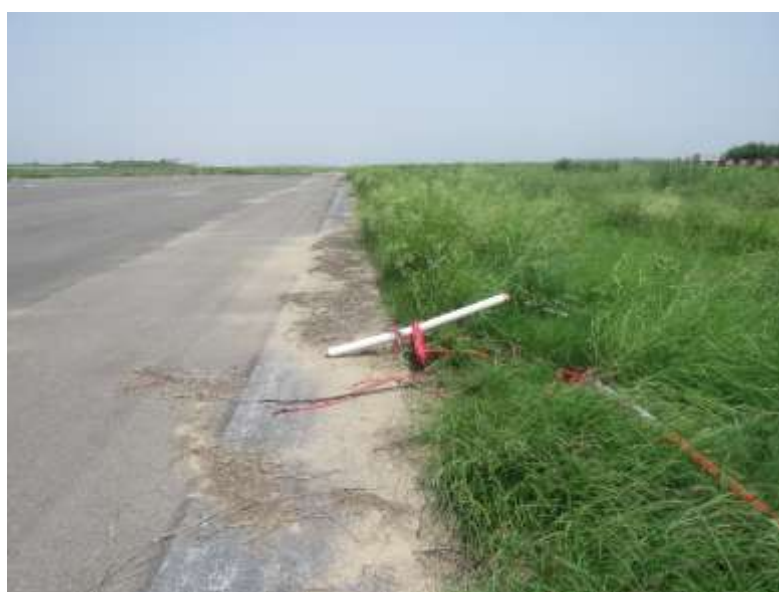
- c) 11 Approach Lights (installed on pavement of the abandoned runway) were damaged.
- d) The Far Field Monitoring Antenna (FFM) and its supporting cables installed on the paved surface (abandoned runway) at 1054.1m from beginning of the abandoned runway, was damaged/ uprooted upon impact with the aircraft. The FFM antenna was recovered on the RH side/ shoulder area of the abandoned runway at approx. 60m from its installed location [FIG 9].

**FIG 9: Location of Far Field Monitoring Antenna after the incident**
